## SERVICE ADVISORY

NO.: 0806 Revision C

**TO:** All Garmin G1000 Customers  
**DATE:** 23 October 2008  
**SUBJECT:** G1000 Transponder Flight Identification Operation  
**REVISION C:** Added GDU software version number

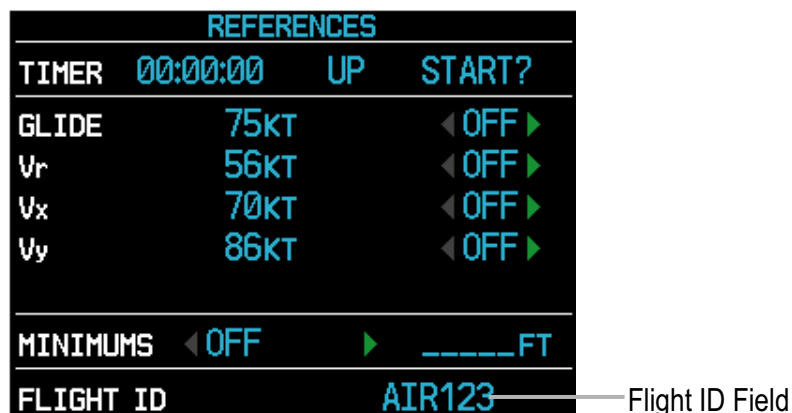
**Figure 1 – PFD Timer Reference Window**

The PFD Entry configuration setting is primarily used outside the continental United States for commercial and/or training operations. Systems with PFD Entry enabled may be readily identified by the presence of a FLIGHT ID field (Figure 1) located at the bottom of the Timer/References Window on the PFD. The Flight ID differs from the 4 digit “squawk” code.

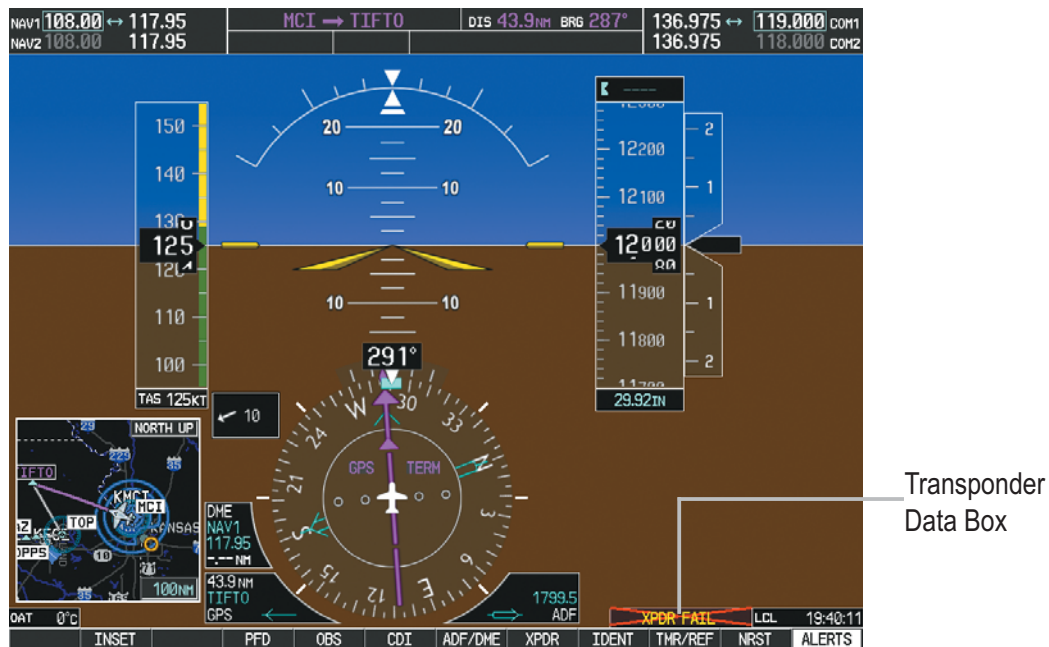
**Figure 2 – Transponder Data Box**

Garmin has identified an issue that is infrequently encountered when entering or changing a G1000 Transponder Flight Identification (ID) number using the Primary Flight Display (PFD) entry method. This issue may cause the following to appear on the PFD:

- A red "X" (failure indication) on the Transponder Data Box
- A "XPDR Config Service" message in the Message Box

If the Transponder Data Box (Figure 2) is marked with a red “X” after entering or changing a Flight ID number, perform the following:

For dual transponder installations:

1. Pull the associated transponder circuit breaker to prevent transmitting an incorrect Flight ID number and/or transponder code
2. Select the opposite transponder using the PFD softkeys.
3. Contact your maintenance organization to service the transponder.

For single transponder installations:

- If airborne, advise Air Traffic Control of a possible transponder failure and follow ATC instructions for continued operation of the transponder.
- If on the ground, contact your maintenance organization to service the transponder.

Maintenance personnel should refer to the airframe’s G1000 System or Line Maintenance Manual for instructions on how to reconfigure the transponder.

System software upgrades containing GDU software version 9.02 and later will resolve this issue. Contact your airframe manufacturer for details.
