SERVICE ALERT

NO.: 0824 Rev C

SUBJECT: GDU 104X CRS/BARO Knob Interference

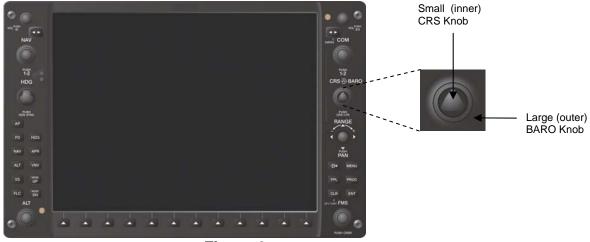
Figure 2

Garmin has identified an issue, whereby the large (outer) BARO knob and the small (inner) CRS knob may interfere with each other.

- 1. Apply power to the G1000/G900X/G950.
- 2. Press the CDI softkey on the Primary Flight Display(s) (PFD) to enter VOR mode on the HSI.
- 3. Rotate the large (outer) BARO knob (refer to Figure 2) a minimum of three complete revolutions in each direction while monitoring the Horizontal Situation Indicator/Digital Course Indicator (refer to Figure 3) on the PFD. If a change in the Horizontal Situation Indicator/Digital Course Indicator is produced while turning the BARO knob contact your local Garmin Service Center or OEM Dealer to replace the knobs.

- 4. Rotate the small (inner) CRS knob (refer to Figure 2) a minimum of three complete revolutions in each direction while monitoring the Barometric Altimeter Setting (refer to Figure 3) on the PFD. If a change in the Barometric Altimeter Setting is produced while turning the CRS knob contact your local Garmin Service Center or OEM Dealer to replace the knobs.
- 5. Repeat Steps 3 and 4 for each affected GDU.
