SERVICE ADVISORY

NO.: 1118 Revision A

TO: Owner/Operators of Garmin Integrated Flight Deck Systems

SUBJECT: Momentary failure indications (Red-X) can occur when sorting stored flight plans

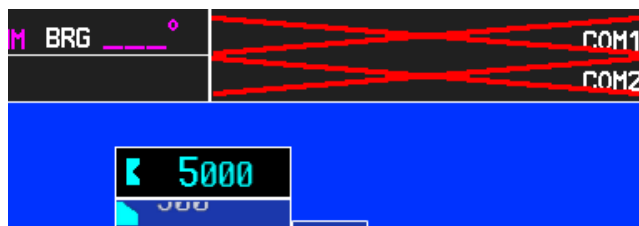
Using the 'Sort By Comment' function on the Flight Plan Catalog Page Menu may cause Red-X failure indications (Figure 1) to appear momentarily in some data field(s), including primary flight data fields, on the PFD(s)/MFD. The auto pilot may disconnect or cause pitch changes to capture changes in airspeed during this condition.

Figure 1. Red-X example

Do not use the 'Sort By Comment' function to sort stored flight plans during flight.

Garmin plans to address this issue in a future software release.
