SERVICE ADVISORY

NO.: 1514 Rev B

DATE: March 25, 2015

SUBJECT: Potential Erroneous Lateral Guidance

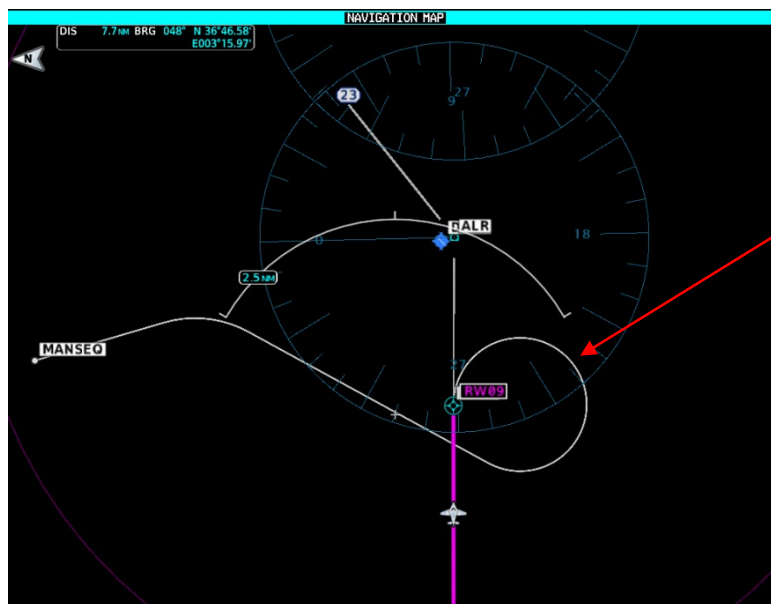
Figure 1 – Erroneous Anticipated Turn (Circular Leg)

Flight management system may provide erroneous lateral guidance when navigating certain legs of a terminal procedure, including SID, STAR, instrument approach, and missed approach procedures. The final approach segment from the FAF to MAP is not affected.

This condition can occur when one procedure (SID, STAR, or instrument approach) is removed from an active flight plan and replaced with a different procedure within the same active flight plan. It may also occur if a SID and/or STAR is added to an active flight plan *after* an approach procedure has already been loaded within the same active flight plan.

The condition appears in the form of a circular leg drawn on the Navigation Map page to indicate a turn in the opposite direction and is added at the intersection of two procedure legs that are not associated with a FAF (see Figure 1).

Monitor the Navigation Map page on the MFD when flying terminal procedures and always compare displayed flight path depictions with applicable published procedures. If this condition occurs, follow CDI course guidance manually and/or by using AFCS Heading Mode.
