SERVICE ADVISORY

NO.: 1516 Rev B

TO: Owner/Operators of G1000 equipped Diamond DA 40 and DA 40F aircraft

SUBJECT: Loss of Engine Indication System (EIS)

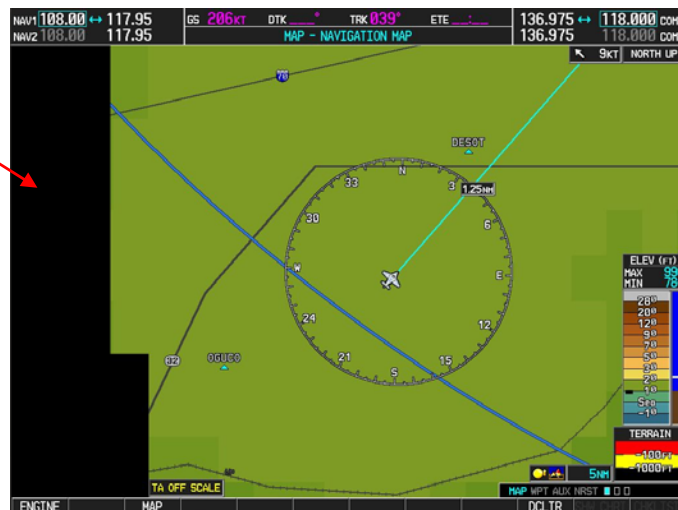
Figure 1 – Loss of EIS Example

Loss of EIS may occur during extended (> 5 seconds) engine shutdowns during flight (see Figure 1). EIS immediately appears after engine restart.

Missing EIS

Contact a Garmin dealer for inclusion of Garmin STC Service Bulletin 1534.
