SERVICE ADVISORY

NO.: 1612 Rev F

TO: Owners and Operators of Garmin Integrated Flight Decks
DATE: November 12, 2020
SUBJECT: 2020 IGRF (International Geomagnetic Reference Field) Magnetic Field Model
REVISION F: Added step to stop power to GIA #2 and operating system specific instructions

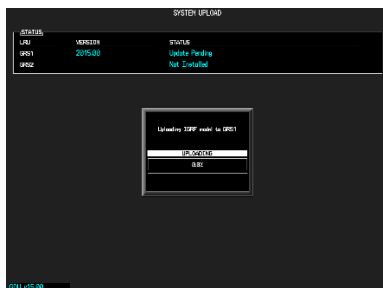
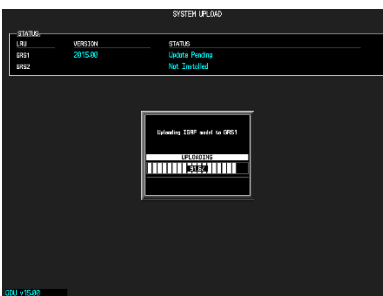
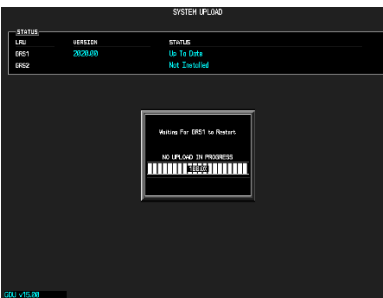
14. Do the following if progress does not begin:
 - a. Stop power to the appropriate GRS.
 - b. Energize the appropriate GRS.

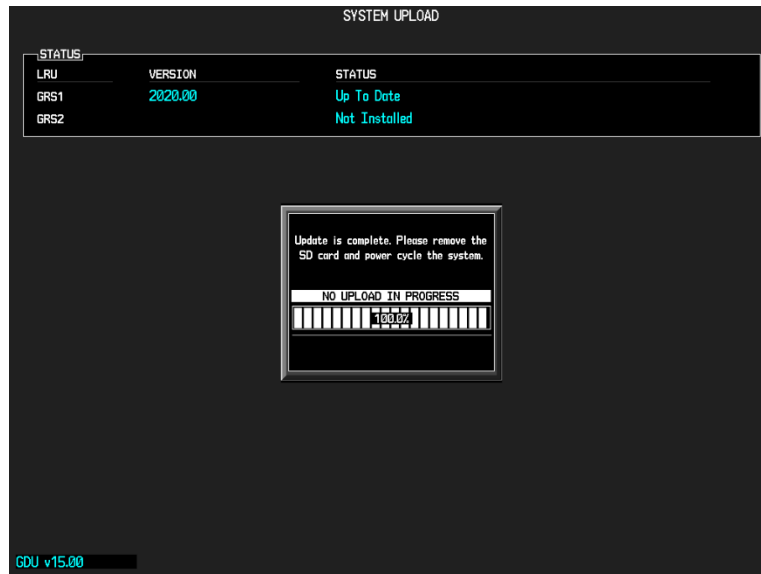
15. When the update is complete this prompt will show on the display.

16. Remove the SD card.
17. Restore GIA #2 circuit breaker.
18. Stop power to the system.
