## SERVICE ADVISORY

NO.: 20109 Rev D

**TO:** Owners and Operators  
**DATE:** October 28, 2022  
**SUBJECT:** Erroneous GPS position and momentary false TAWS alerts  
**REVISION D:** Added GPS 175/GNX™ 375/GNC® 355 and GTN Xi Resolution

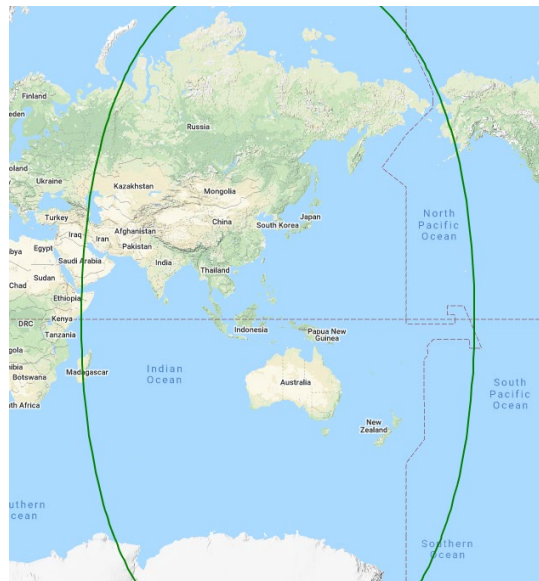
All SBAS-enabled Garmin Integrated Flight Decks (G900X, G950, G1000(H) G1000(H) NXi, Cirrus Perspective™, Embraer Prodigy™, G2000, G3000, G5000, and Embraer Prodigy® Touch systems), GTN Xi Series, GPS 175, GNX 375, GNC 355, GNS 400W/500W Series, GNS 480, GTN 6XX/7XX Series products operating within the area depicted below are affected.
