# SERVICE ADVISORY

NO.: 0837

**TO:** All Garmin Aviation Service Centers  
**DATE:** October 27, 2008  
**SUBJECT:** G600 NAV/ILS Glideslope Display and GPS signal

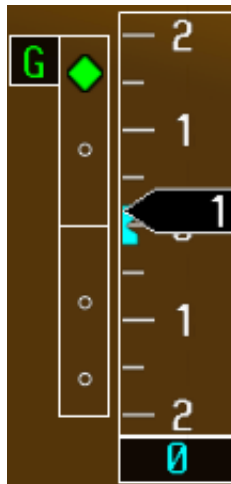
In GDU 620 version 2.01 software, ILS glideslope information will only be displayed if the GDU 620 has valid GPS position information. On the PFD, glideslope information is displayed immediately to the left of the VSI indicator, as shown below. The display of localizer information is not affected.

**LOC/ILS is the selected navigation source**

A future software version will address this issue where the GDU 620 will not require valid GPS position in order to display ILS glideslope information.
